Date: April 19, 2005	Bulletin Number: 05D-J-076
To: All Distributors and Jobbers	Category: Service
From: Stephen Sigg, Product Service	Line(s): 14

**Subject: Possible Incorrect Placement of Inboard and Outboard 17D-727 Brake Pads**

**Vehicles Involved:** 1997 - 2005 Chevrolet Malibu  
1997 - 1999 Oldsmobile Cutlass  
1999 - 2004 Oldsmobile Alero  
1999 - 2004 Pontiac Grand Am

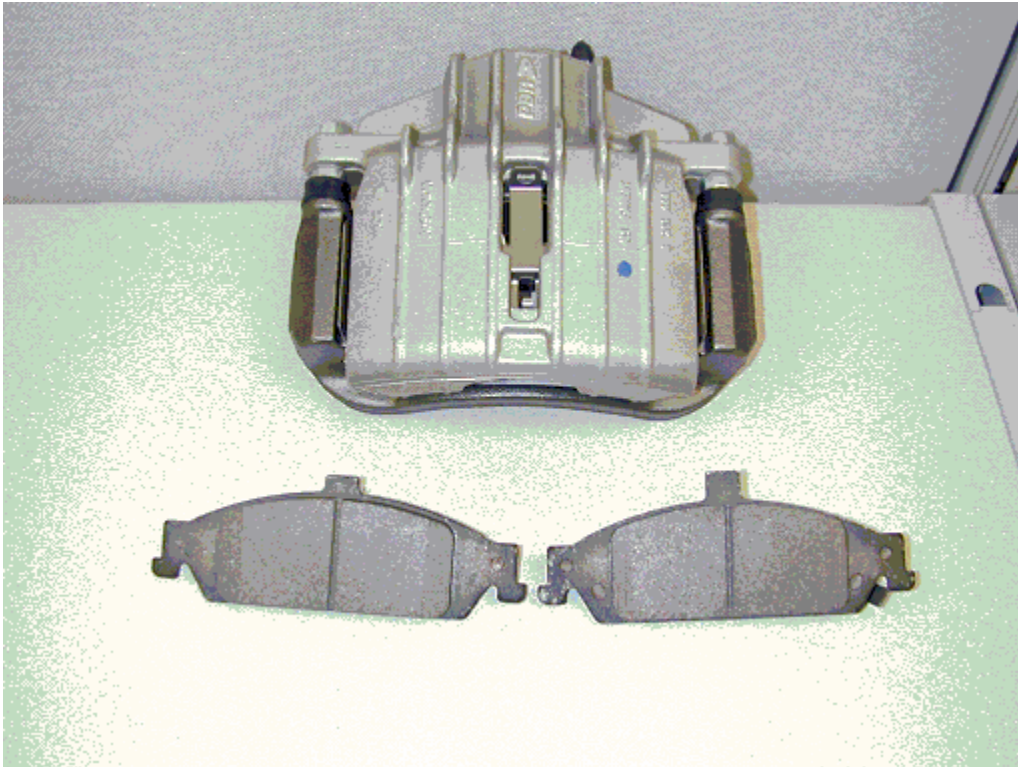
**Figure 1**

Figure 1 shows the difference in the inboard pad. Note that the pad with the wear indicator has a taller center-positioning tab on it. If the pad with the taller center-positioning tab is mounted as the outboard pad, the taller tab will bind the pad in the caliper top pad-positioning clip. This will cause pad misalignment and caliper slide binding.

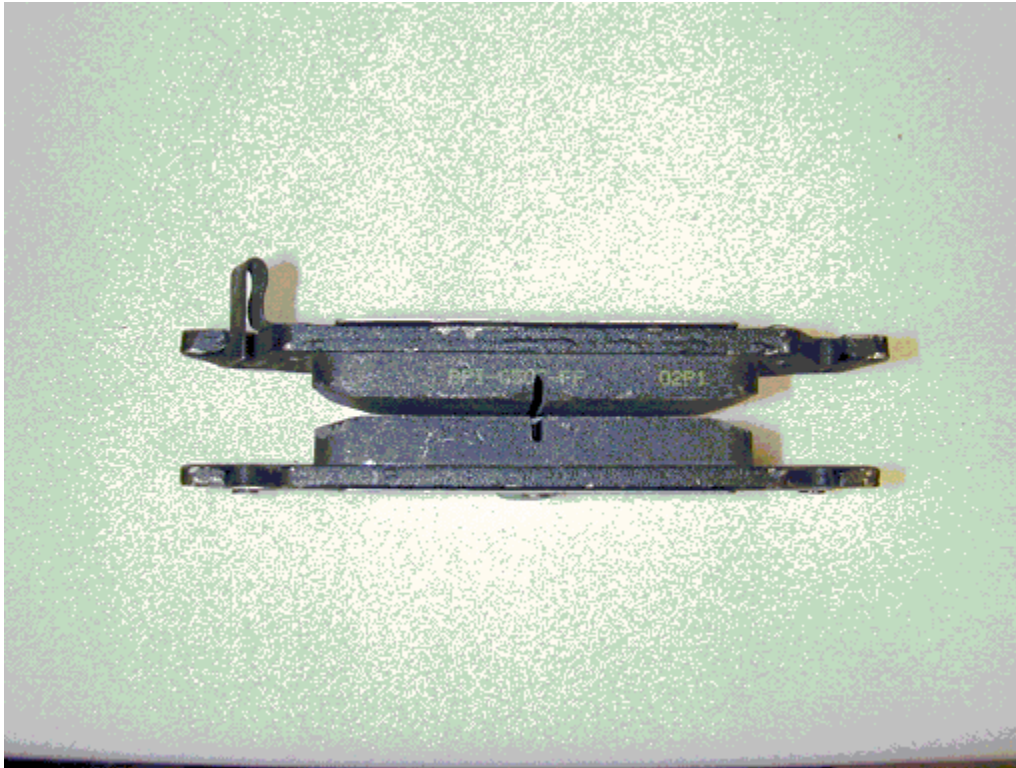
**Figure 2**

It should be noted, as shown in Figure 2, that the inboard pad has a thicker metal backing and a thinner friction block than the outer pad. This, in addition to the wear indicator, will assist you in identifying which pad should be mounted inboard and which should be mounted outboard. A considerable amount of effort must be placed on mounting the wrong pad outboard. You should not grind the length of the center-mounting tab to enable the pad to be installed. If the center-positioning tab appears to be too long you have the pads mounted incorrectly.
