Chassis Parts – Service Information

Subject: Inspection of worn or damaged upper control arms (**stamped steel versions**) and replacement with upper ball joint (**ACDelco# 45D0104**) that must be properly indexed

Vehicles Involved: 1999-2006 Cadillac Escalade ESV, Chevrolet Avalanche ¾ ton, Suburban ¾ ton, Silverado ½ ton HD, ¾ and 1 ton. Express Cab, Hummer H2, GMC Sierra ½ ton HD, ¾ and 1 ton, Yukon XL. (Please refer to catalog for specific vehicle applications)

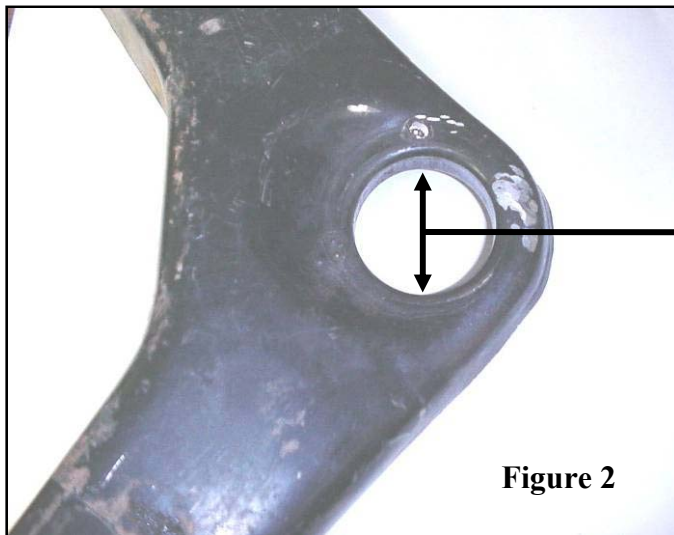
Figure 2

Control arm holes that exhibit any signs of wear, fatigue, oblong shape or other visible damage **must** be replaced (Figure 2).

Check hole for elongation, wear, fatigue, or other damage

ACDelco now offers a complete control arm assembly (**45D1083**) with the ball joint (**45D0104**) already installed for those repairs that may require the assembly due to a problem with the control arm hole.

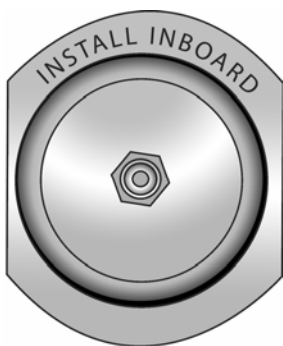
Figure 3

Stamped on the bottom of the upper ball joint (Figure 3) are the words, "INSTALL INBOARD". It is important that the new ACDelco ball joint (45D0104) be installed with those words "INSTALL INBOARD" facing towards the engine compartment of the vehicle (Figure 4).

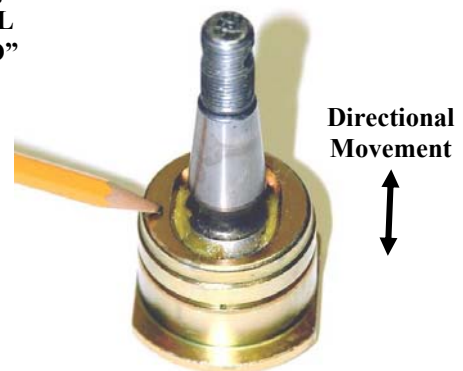
Figure 5

Because the ball joint is a "directional" type (Figure 5), the swing angle of the ball joint stud is limited in its range of motion (inboard-to-outboard). Incorrect installation (i.e., orientation of the housing) could cause damage to the ball joint resulting in premature failure.
