Chassis Parts – Service Information

Subject: Inspection of worn or damaged upper control arms (**stamped steel versions**) and replacement with upper ball joint (**ACDelco# 45D0104**) that must be properly indexed

Vehicles Involved: 1999-2006 Cadillac Escalade ESV, Chevrolet Avalanche ¾ ton, Suburban ¾ ton, Silverado ½ ton HD, ¾ and 1 ton. Express Cab, Hummer H2, GMC Sierra ½ ton HD, ¾ and 1 ton, Yukon XL. (Please refer to catalog for specific vehicle applications)

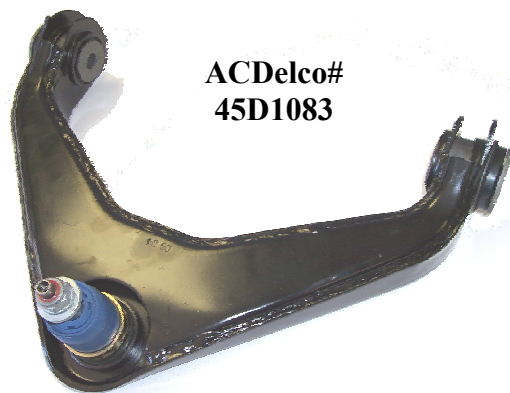
**ACDelco#
45D1083**

ACDelco now offers a complete control arm assembly (**45D1083**) with the ball joint (**45D0104**) already installed for those repairs that may require the assembly due to a problem with the control arm hole.
